INDIAN LAKE DAM

(NDI I.D. PA-0057

DER I.D. 058-038)

PHASE I INSPECTION REPORT

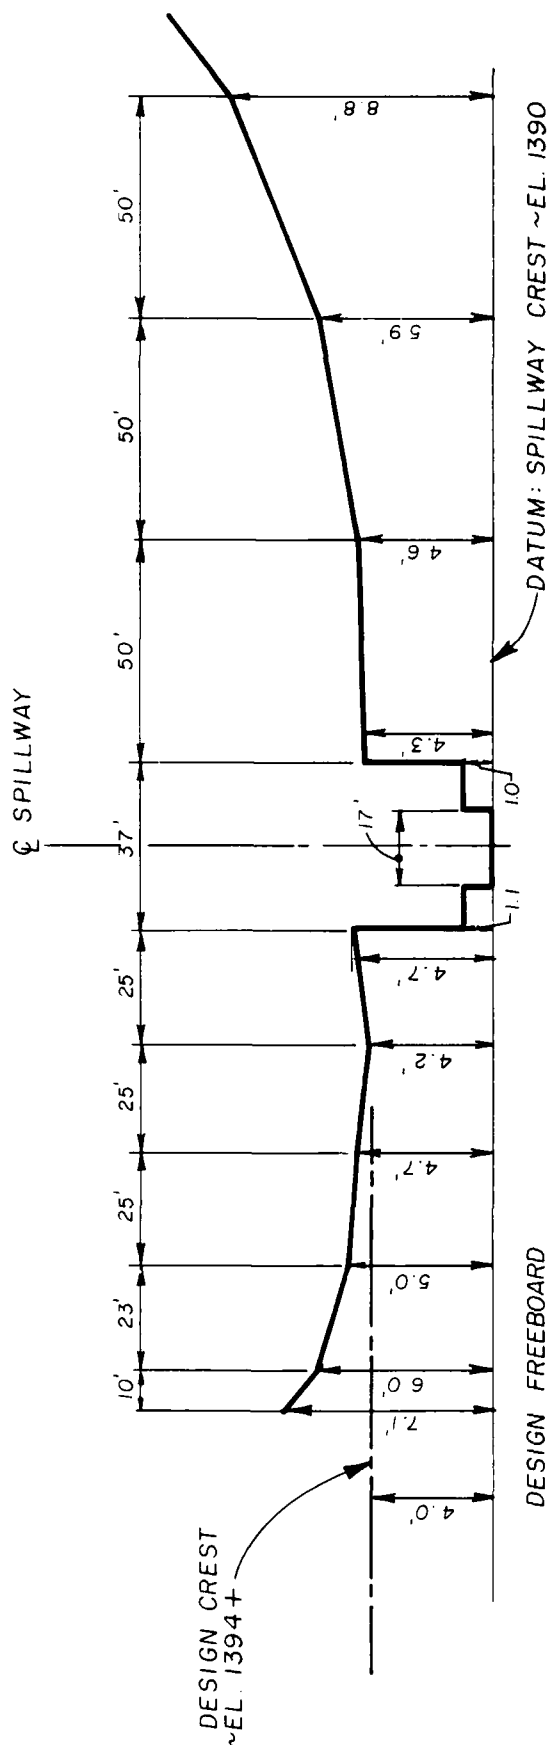
## DAM CREST PROFILE

The top of the dam was surveyed relative to the spillway crest elevation and was found to have some vertical irregularities (see Plate 5). While the design freeboard for the dam was four feet, the field survey indicated a freeboard of 4.2 feet between the low spot on the left embankment and the spillway crest.
